40 YEARS OF RESTORATION AT TIJUANA ESTUARY, CALIFORNIA

LESSONS LEARNED

40 YEARS OF RESTORATION AT
TIJUANA ESTUARY, CALIFORNIA
LESSONS LEARNED

SEPTEMBER 2018

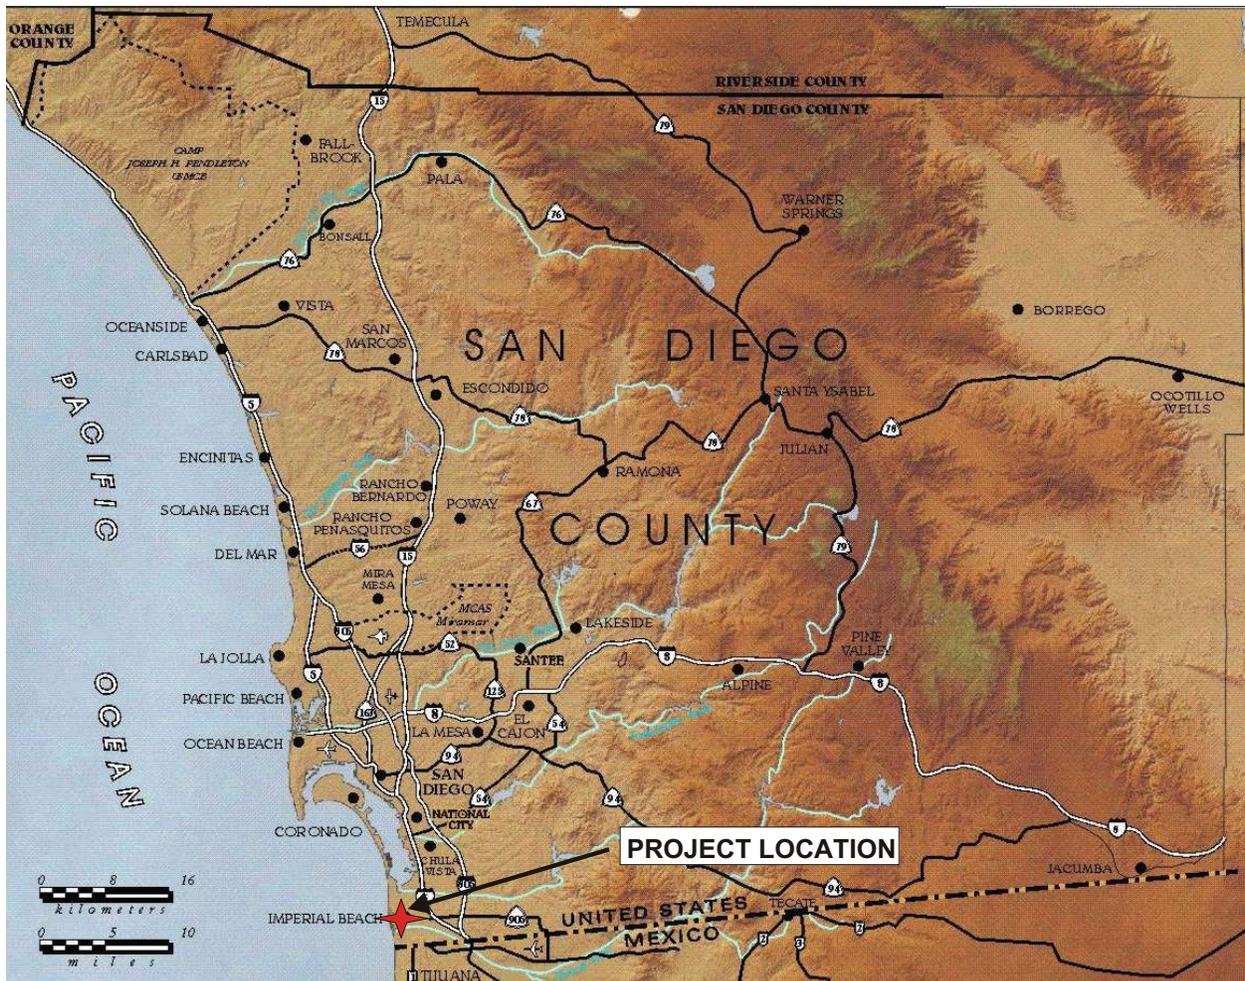
FIGURE I. REGIONAL LOCATION MAP

TIJUANA ESTUARY, located in the southwestern corner of the continental U.S. (Figure 1, next page), has a complex history; ecologically, politically and geographically. Ecologically, the estuary has relatively large natural areas, although these tend to be modified and managed. Politically, the estuary has survived attempts at development and is currently managed by a number of federal, state and local agencies and entities. Geographically, Tijuana Estuary is surrounded by the cities of San Diego, Imperial Beach and Tijuana and has been negatively impacted by land use practices on both sides of the border. Because of this high density human population, inadequate sewer systems, unstable slopes and soils, and agricultural activities, Tijuana Estuary has been plagued with water quality and sedimentation problems. These problems were accelerated in the 1980s associated

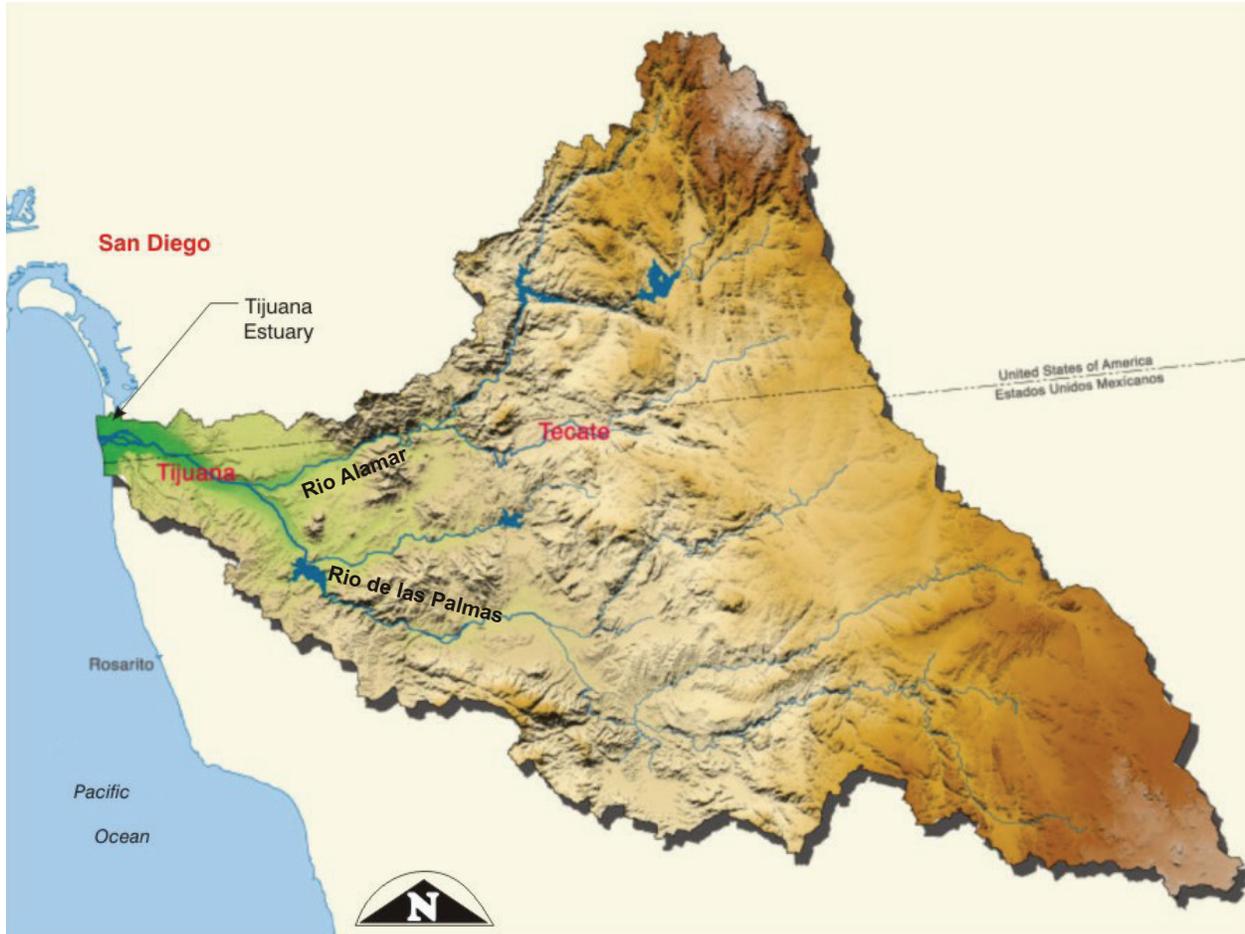
FIGURE 2. WATERSHED MAP

Tijuana Estuary is located in the southwestern-most corner of the continental U.S in San Diego County. While the estuary is located entirely within San Diego County, three fourths of its watershed is within Mexico (Figure 2) and is, thus, beyond the control of U.S. interests. The Tijuana River

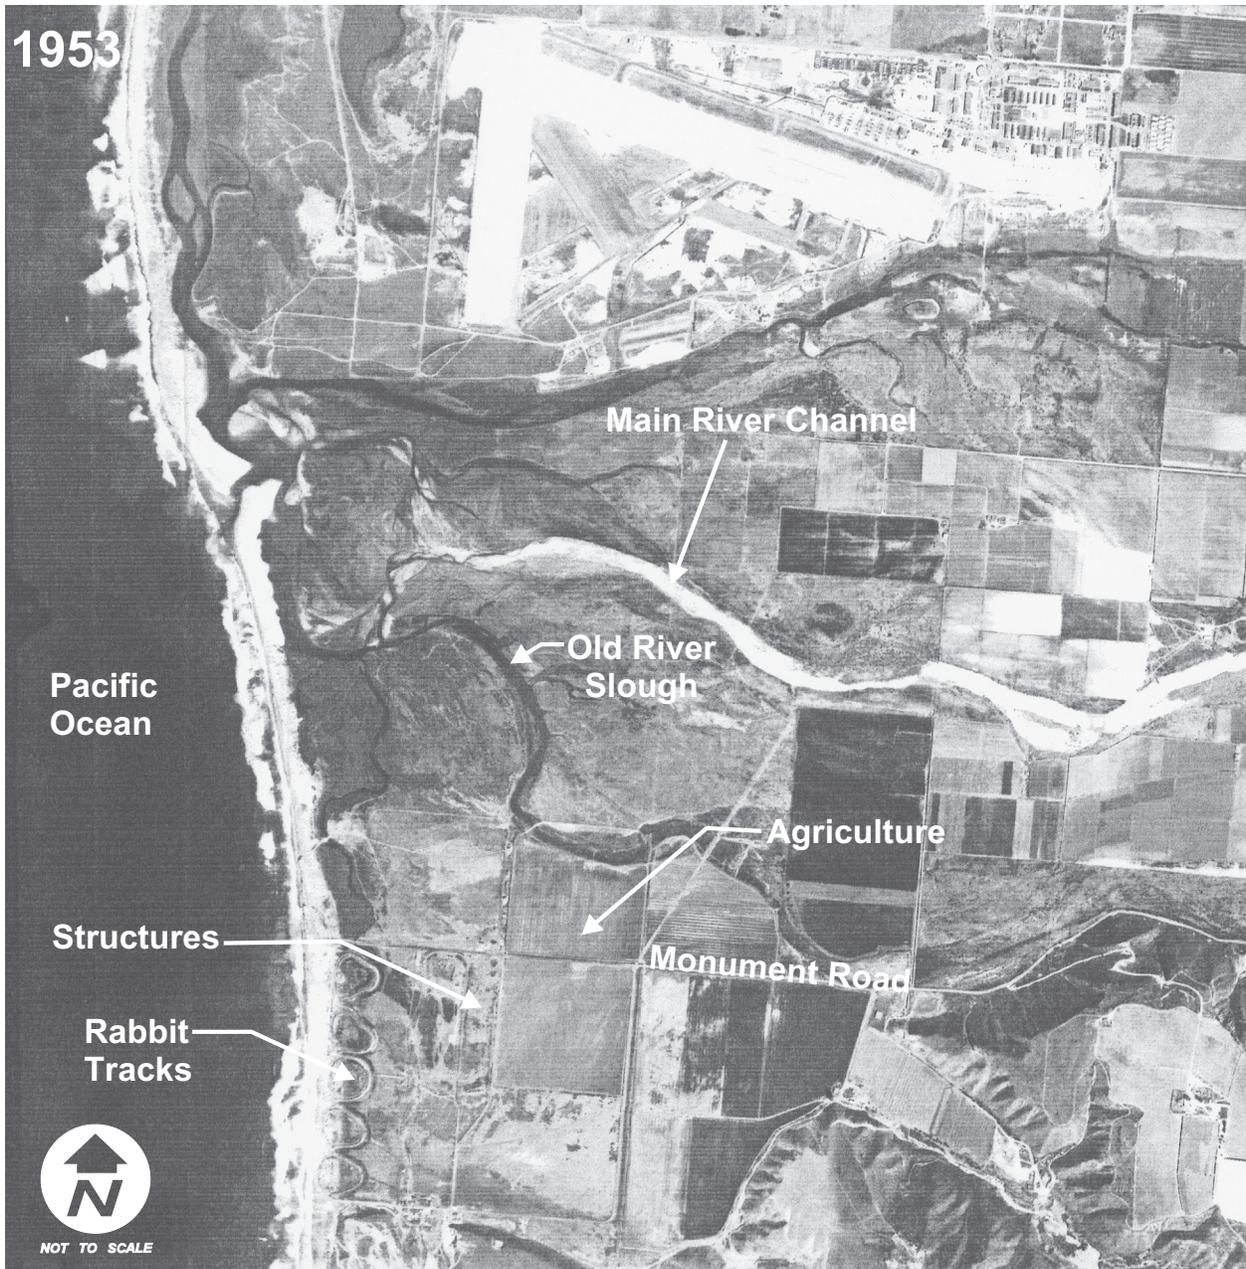
FIGURE 5. 1953 AERIAL PHOTOGRAPH OF TIJUANA ESTUARY

Because it is important to illustrate the changes that have resulted in the need for large-scale restoration, a brief history of land use and disturbance in the area is presented. Much of the land in the river valley was farmed and later abandoned. A 1953 black-and-white aerial photograph (Figure 5) shows active farming within the central

and southern estuary. Cultivated fields are shown very near the coast, suggesting that the ground water was close to the surface and relatively fresh, and that seawater had not intruded far inland. The Tijuana River appears to be active in the center of the river valley as evidenced by sand deposition, as opposed to major channels located on the north and south ends of the valley. More recently, the water table in the project area has fluctuated from within a few feet of the surface with salinities of one–two parts per thousand (ppt) in 1986–1987 at the Pacific Estuarine Research Laboratory (PERL) operated by SDSU (C. Nordby, unpublished data) to more than 15 feet below the ground surface with salinities greater than 38 ppt at Goat Canyon in 2002 (Tierra Environmental Services [Tierra] 2002). Currently, large-scale agricultural uses are confined to the eastern end of the Tijuana River Valley (Figure 4).

Military activity was also evident within the estuary in 1953 (Figure 5). The U.S. Navy began acquiring Border Field property in

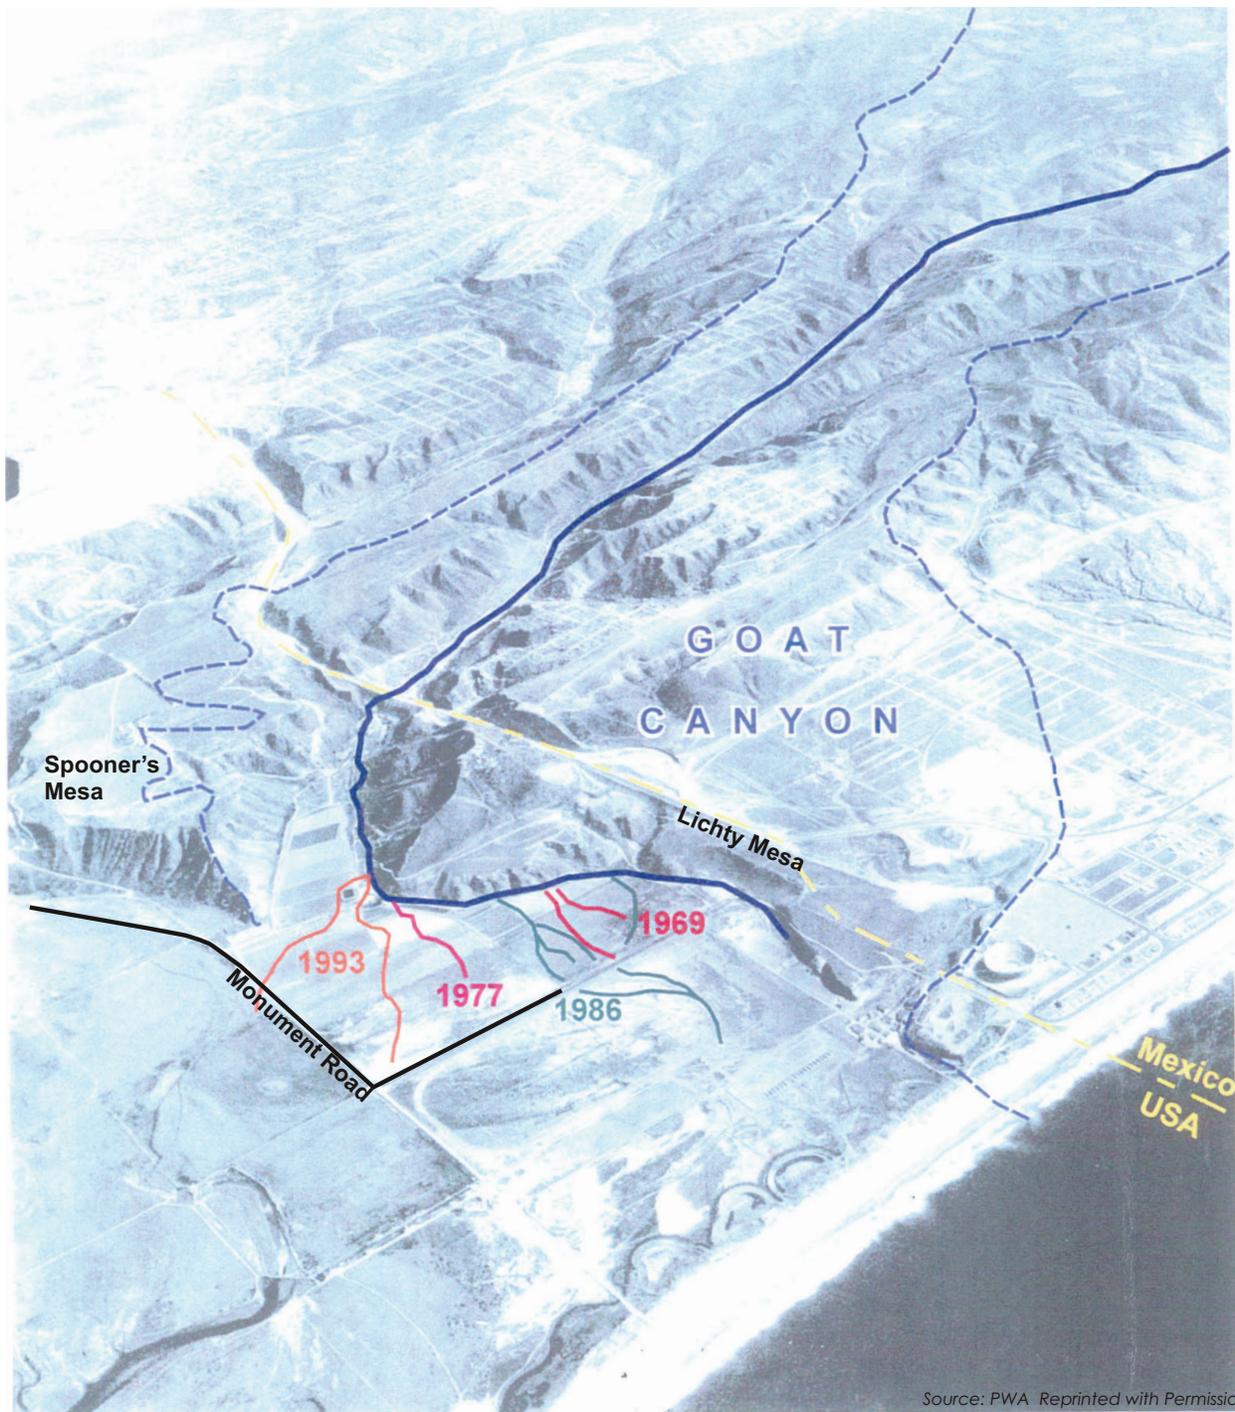
FIGURE 8. HISTORIC MIGRATION OF GOAT CANYON CREEK

Sediment deposited by creek migrations buried Monument Road and have impacted the salt marsh-salt panne habitat west of the road. In addition, seeds of exotic plant species, in particular annual grasses, mustards (*Brassica* spp.) and crown daisies (*Glebionis coronaria*), have invaded the disturbed landscape. As a result, habitat that was once considered valuable seasonal wetland has become both elevated and degraded.

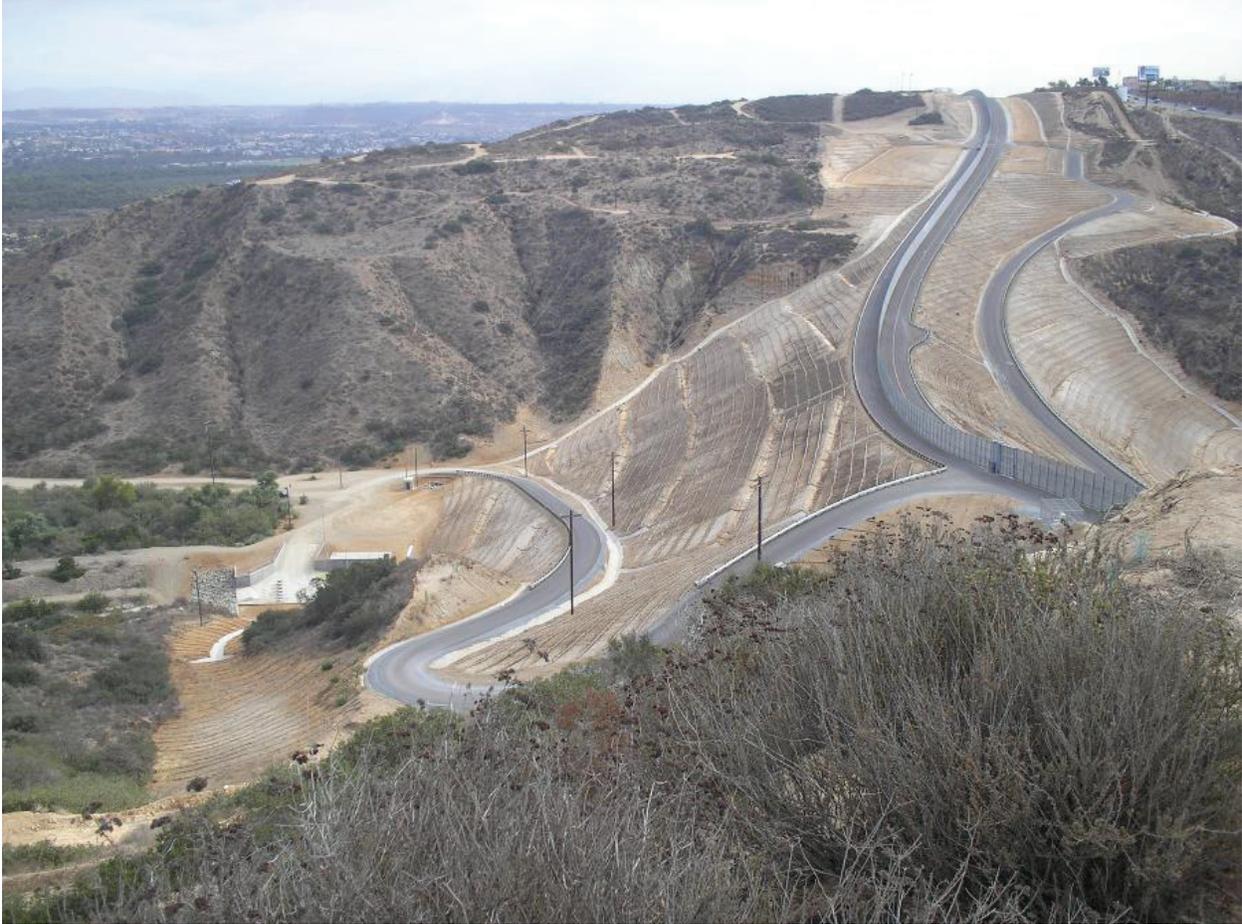
FIGURE 10. SMUGGLER'S GULCH FILL

habitats within the TRNERR and County Park, and constructed the border fence on top of the berm (Figure 10). There was little or no effort to revegetate the bare slopes which threatened to wash into the estuary. Eventually, with pressure from resource managers, a revegetation program was initiated along some of the slopes.

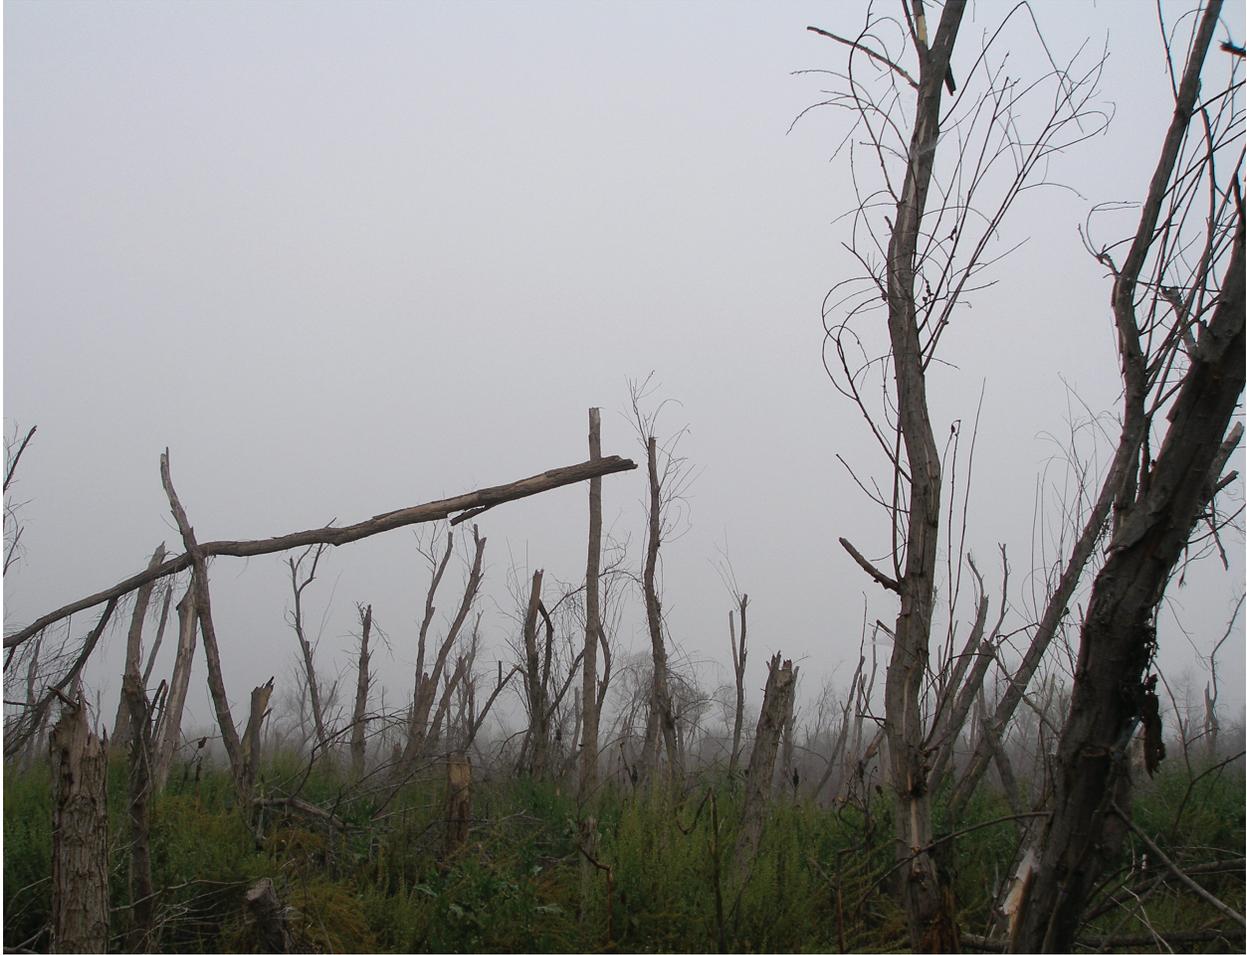
FIGURE II. SHOT HOLE BORER DEVASTATION

In 2015, managers within the Tijuana River Valley began noticing die-off of the willow woodland associated with the river. After close analysis, it was determined that the cause was two species of non-native beetle, the Kuroshio shot hole borer beetle. Both are members of the genus *Euwallacea*. These beetles burrow into tree bark and infect the trees with at least two fungal species. The fungus grows within the tree and the beetle larvae feed on the fungus until maturity. The fungus disrupts the tree's metabolic processes in a process known as "Fusarium die-back" (*Fusarium euwallaceae*) leading to branch loss and ultimately, in many cases, death of the trees. Willows are not the only type of trees affected. Other species include sycamores and oaks, avocado and

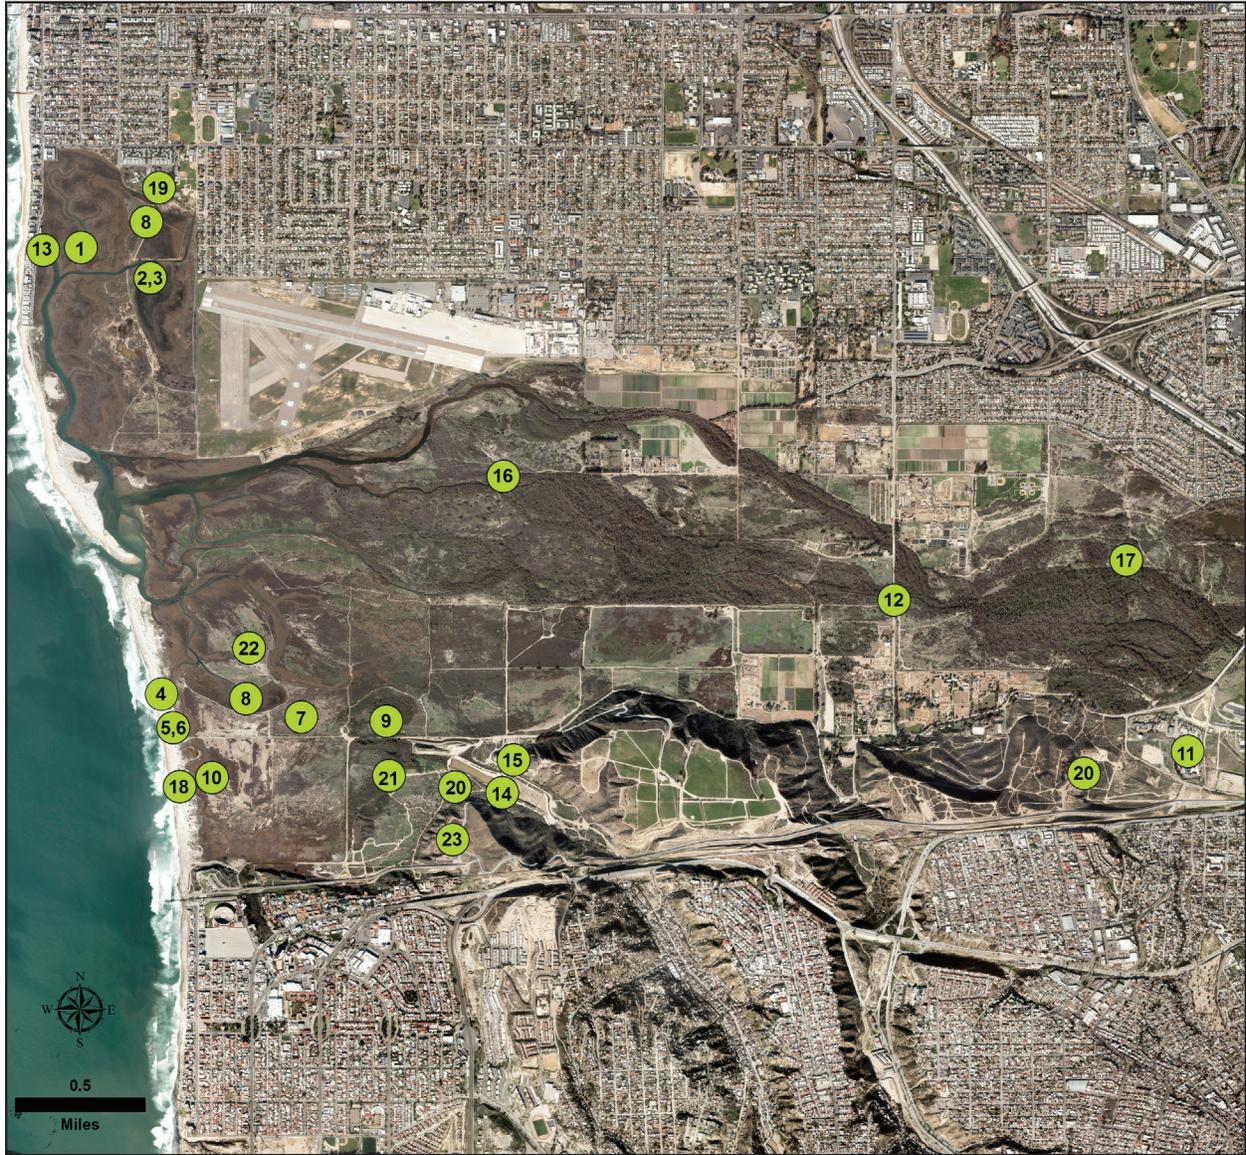
FIGURE 12. LOCATIONS OF RESTORATION PROJECTS IN THE VALLEY

Each of the projects described here, as well as other studies and on-going research on restoration at Tijuana Estuary, are described in detail in the following sections. A map depicting the locations of each of the restoration sites listed in Table 1 is presented in Figure 12.

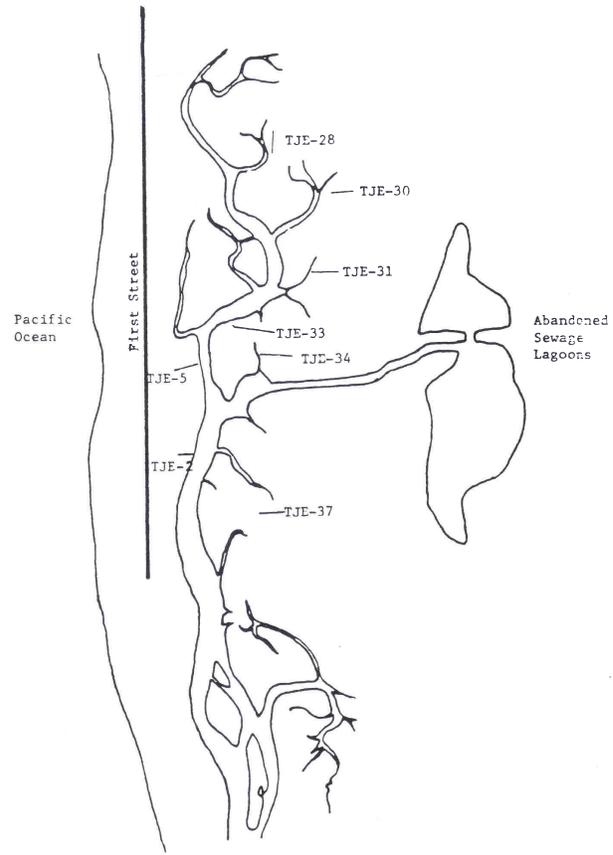
FIGURE 13.
CORDGRASS TRANSECTS ESTABLISHED
IN 1980

It had been hypothesized that the reduction in clapper rail nests seen in 1979 (16 nests) compared to 1974 (22 nests) had been the result of a decline in formerly pure stands of cordgrass and replacement with a mixture of cordgrass and succulent species. In order to test this hypothesis, eight areas of cordgrass within Oneonta Slough that were thought to be declining at their landward boundary were selected for a detailed study of height,

density and number of live and dead stems. The ratio of live to dead stems was used to determine whether that particular stand was declining or increasing (Zedler et al. 1979).

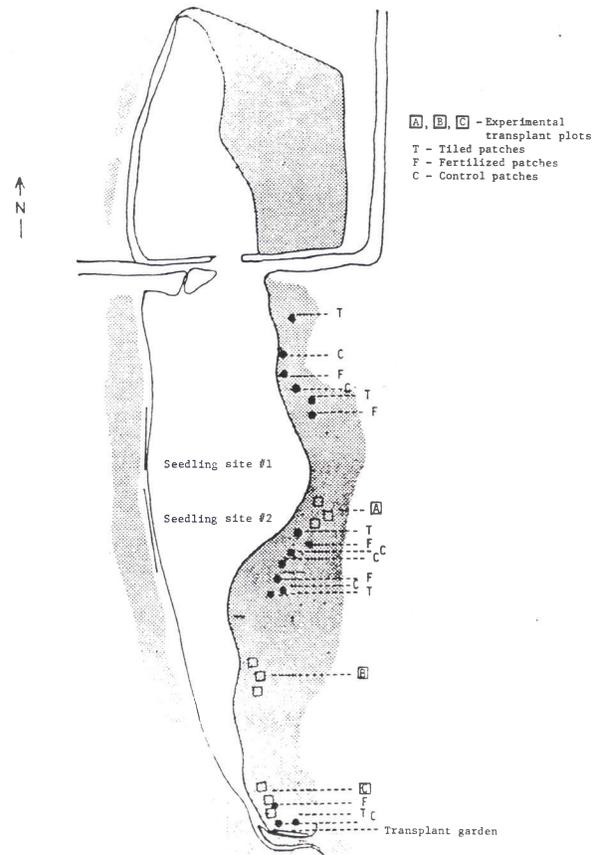
FIGURE 14.
CORDGRASS SEEDLING TRANSPLANT
GARDENS 1980

Transplant Gardens from Mature Stands. One hundred shoots of cordgrass were transplanted along a tidal creek located at the south end of the sewage lagoon in June 1980 (Figure 14). The creek banks appeared to be suitable habitat for cordgrass, yet none had become established.

Nine experimental transplant gardens were established in June 1980 to test the effects of tiling to improve surface drainage and fertilization with nitrogen in the form of urea. Three groups of three, two-m² plots were established in locations A, B and C (Figure 14). Thirty-six cordgrass sprigs were transplanted in each plot. Within each group, one plot was fertilized with 10 gallons of urea/m² every two weeks, one plot was tiled with Spanish-type roofing tiles to improve surface drainage, and one plot served as a control.

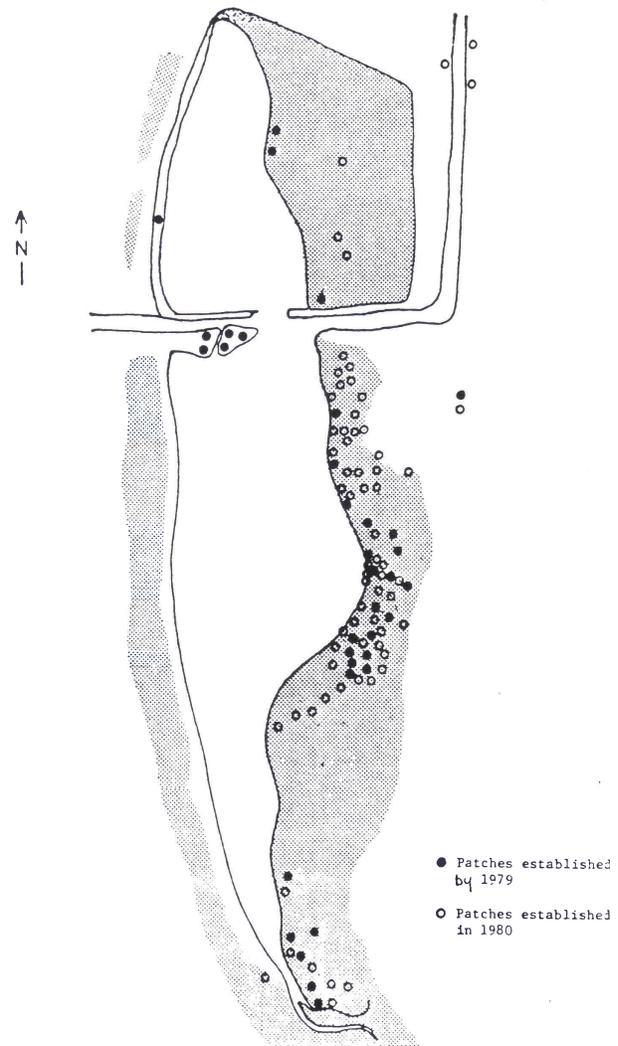
FIGURE 15.
CORDGRASS PATCHES AT FORMER
SEWAGE LAGOONS 1979–1980

Associated research had indicated that the highest establishment from seeds for cordgrass was obtained by submerging seeds in water with low salinity. Interstitial soil salinity decreased dramatically in 1980 due to freshwater input from winter storms. Measurements in the marsh associated with Oneonta Slough documented this decrease and its effect on cordgrass density and height. The 101 0.25-m² quadrats sampled in the previous study, Clapper Rail Habitat: Requirements and Improvement, were re-sampled. In October 1979, overall mean soil

salinity was 43.8 ppt. In April 1980, following February flooding, mean soil salinity had dropped to 14.8 ppt. By September 1980 it had risen again to 41.0 ppt. When height and density of cordgrass were compared for September 1980 and September 1979, there was an increase in density of 17 shoots/m², a 19-cm increase in mean height, a 30-cm

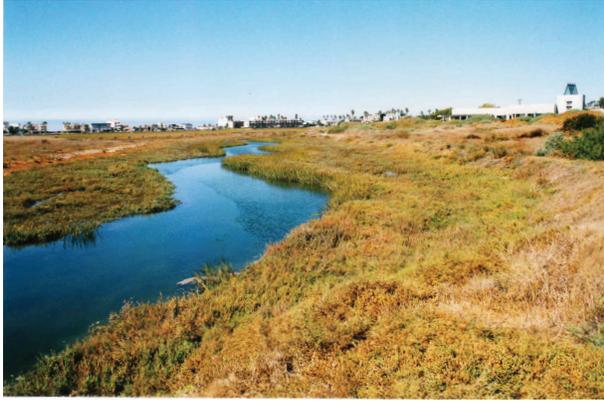
FIGURE 19.
CONNECTOR CHANNEL 1996

In response to researcher request, the Tidal Linkage included a sinuous main channel with a salt marsh plain on each side that included low, mid- and high salt marsh elevations (Figure 19). Plants salvaged from existing salt marsh at the west and east end

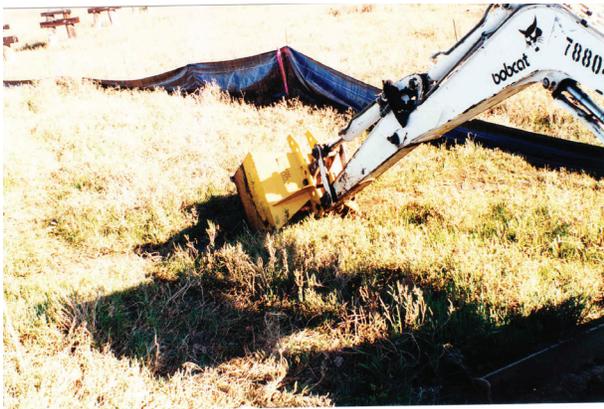
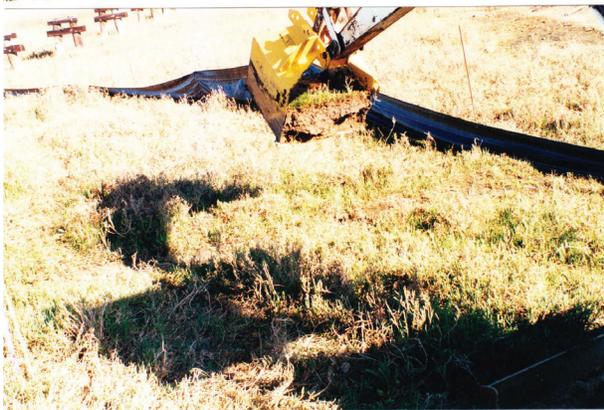
FIGURE 20.
BOBCAT EXCAVATOR WITH
CUSTOMIZED BUCKET

Tidal Linkage marsh plain, further excavation was conducted with conventional, full-size excavators. The material excavated was placed in a deep, water-filled pit where a small cutterhead dredge created a slurry that was pumped approximately one mile to the beach for disposal in the upper surf zone. Approximately 18,000 yd³ of excavated soils were disposed of in this manner.

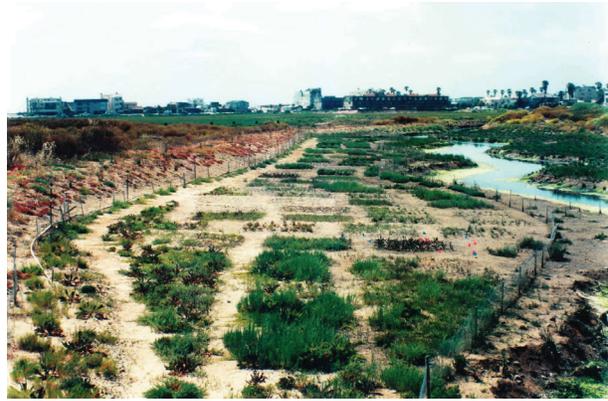
FIGURE 22. EXPERIMENTAL PLOTS AT CONNECTOR CHANNEL

species-rich assemblages. The experiment had five blocks with 15 two-meter x two-meter plots/block (Figure 22). The plots were planted with zero, one, three or six native halophytes randomly selected from a pool of eight native species. Planted treatments had 90 seedlings spaced on a 20-centimeter grid. Due to random selection of each species, all eight species were planted at approximately equal quantities (790 seedlings/species). Additional test plots were established to assess the role of processed kelp as a soil amendment on plant establishment and growth.

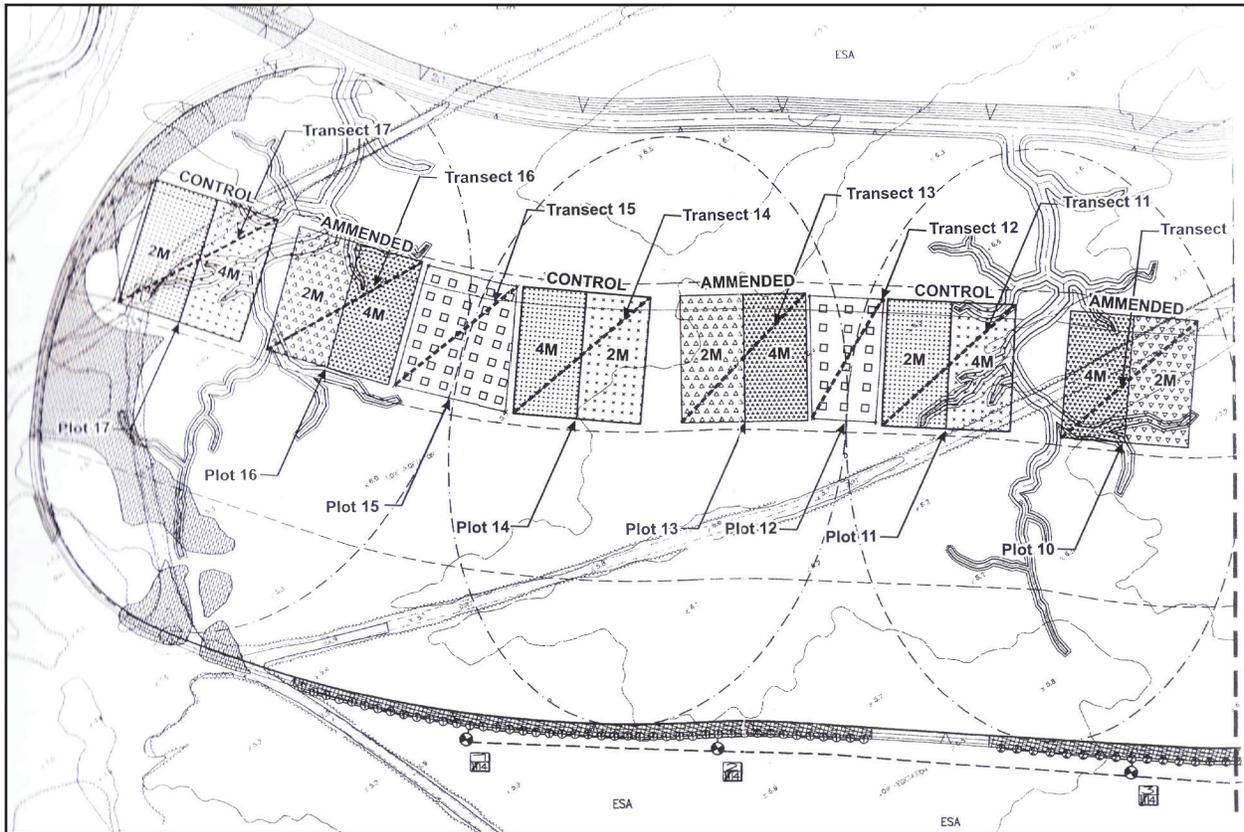
FIGURE 25A. DESIGN OF MODEL MARSH

a result, the excavated marsh plain dried out and became hypersaline. All 5,000+ planted seedlings died. Researchers did not have enough remaining seedlings to reestablish the entire marsh plain, so they designed a new experiment with 180 plants (five-species assemblages introduced with varied cluster density, varied proximity to creeks, and with or without the soil amendment (kelp compost). Monitoring showed that all three treatments increased establishment or growth of at least one species in the assemblage.

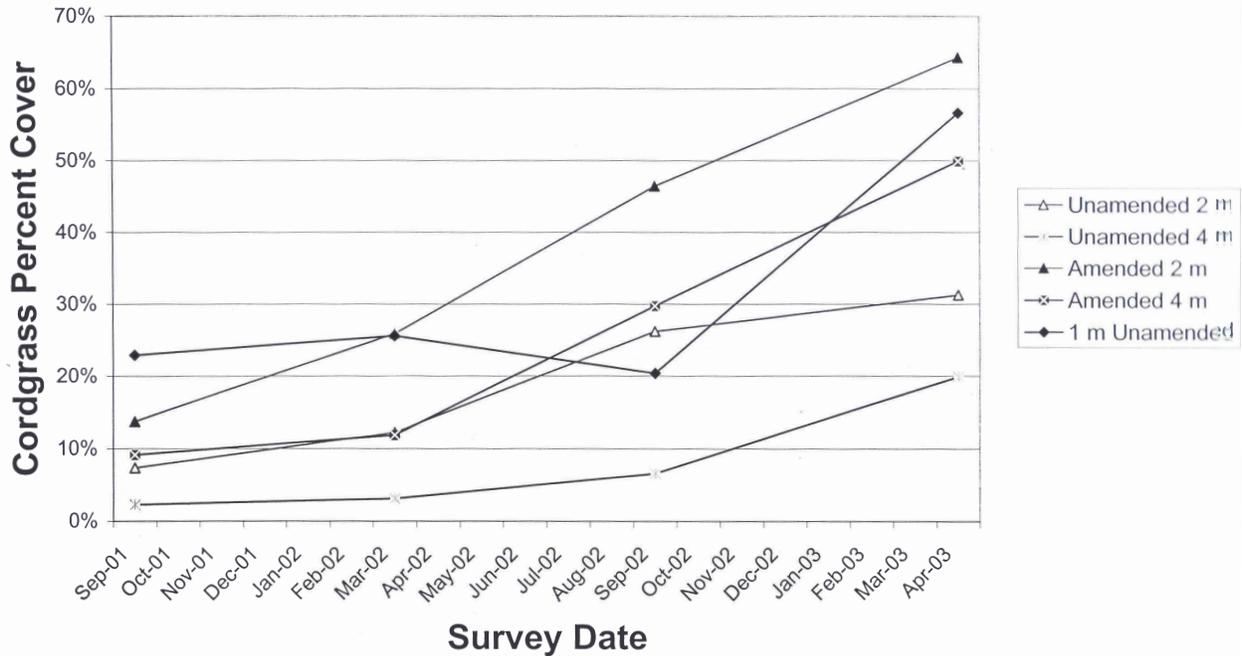
FIGURE 26. CORDGRASS GROWTH GRAPH

March 2002 and April 2003 (Figure 26). Cordgrass planted on two-meter centers with soil amendments showed a greater increase in cover over time than unamended plots with cordgrass planted on one-meter centers. Amended plots planted on four-meter centers increased nearly as much as unamended plots planted on one-meter centers (Tierra Environmental Services 2004).

Figure 15. Cordgrass Vegetative Cover for 2 m, 4 m, and 1 m Densities within Unamended and Amended Plots

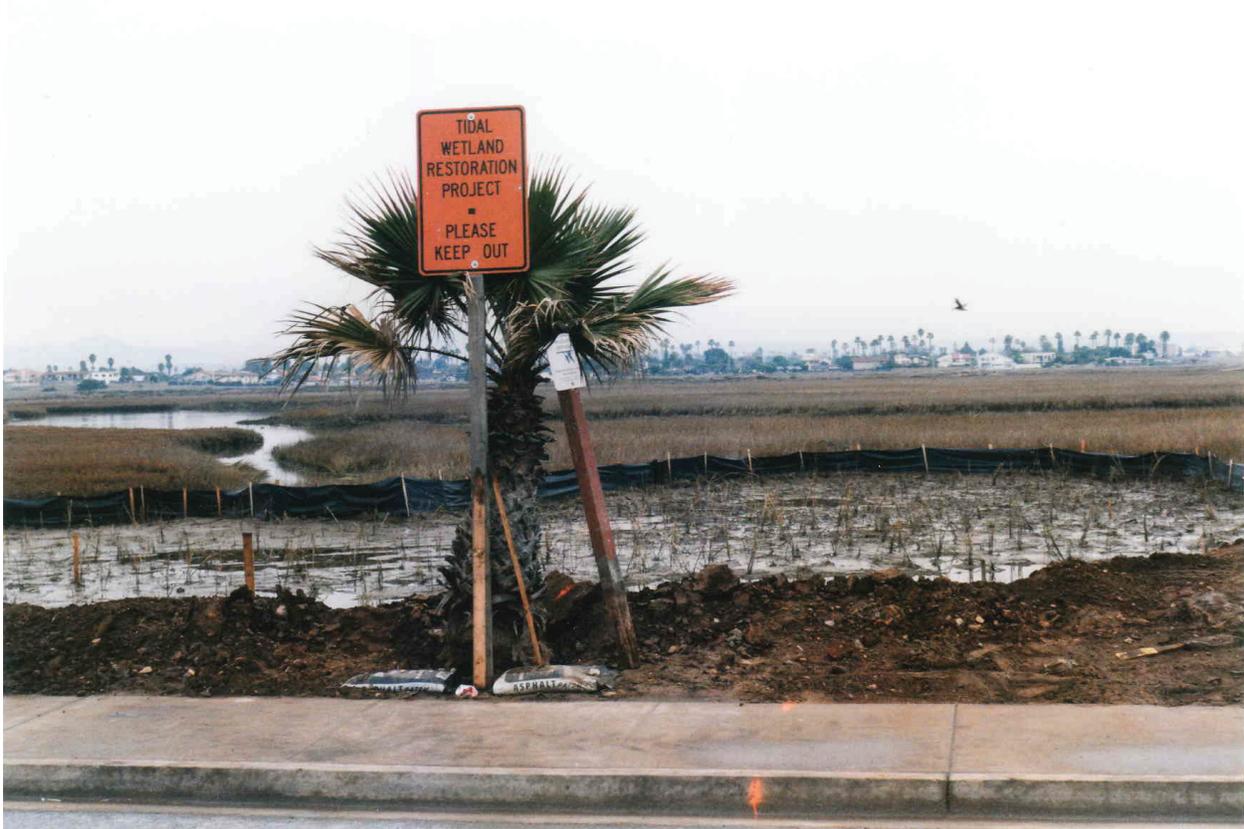
FIGURE 31. NAPOLITANO SITE

The Napolitano Restoration Project entailed the removal of approximately 9,000 cubic yards of fill deposited in the intertidal salt marsh to create a pad for a residential development in the northern arm of Tijuana Estuary adjacent to Seacoast Drive (Figure 31). The 1.25-acre fill was created in the 1970s under a grading permit issued by the City of Imperial Beach and had been used as an unofficial parking lot by residents of Imperial Beach. It was restored by Caltrans as a Supplemental Environmental Project as part of a settlement agreement with the U.S. Environmental Protection Agency, the Natural Resources Defense Council, and the San Diego Baykeepers regarding the discharge of Caltrans storm drains into San Diego Bay. Caltrans acquired the

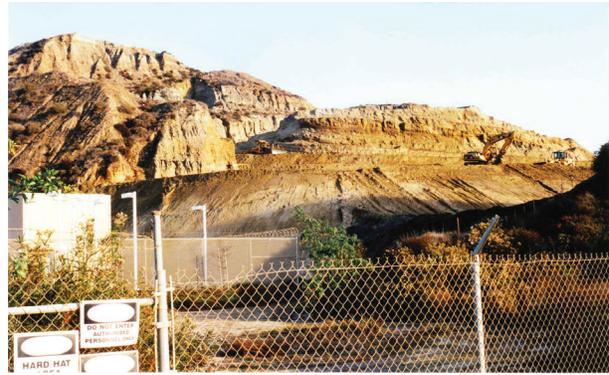
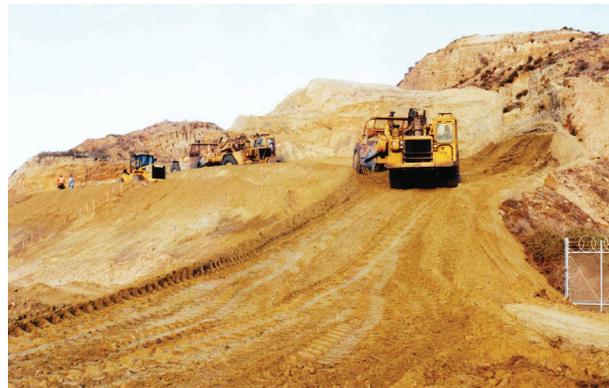
FIGURE 34. FENTON QUARRY

Approximately 100,000 yd³ of stockpiled soils were transported into the quarry using belly dump trucks, excavators, bulldozers and front loaders. Slopes were stabilized using layers of geotextile plastic. Once the slopes were deemed stable by the geotechnical consultant, non-saline soils were used to cap the saline soils from the Model Marsh. A uniform four-foot thick layer of capping soil, excavated from the quarry for this purpose, was distributed over the top and slopes of the restored quarry. Once in place, the capping soils were compacted and contoured.

The approximately 100,000 yd³ of soil did not completely fill the quarry as planned by the project engineer. The engineer had developed the plans based on the amount of soil excavated during construction of the Model Marsh—approximately 133,000 yd³. This discrepancy was never resolved.

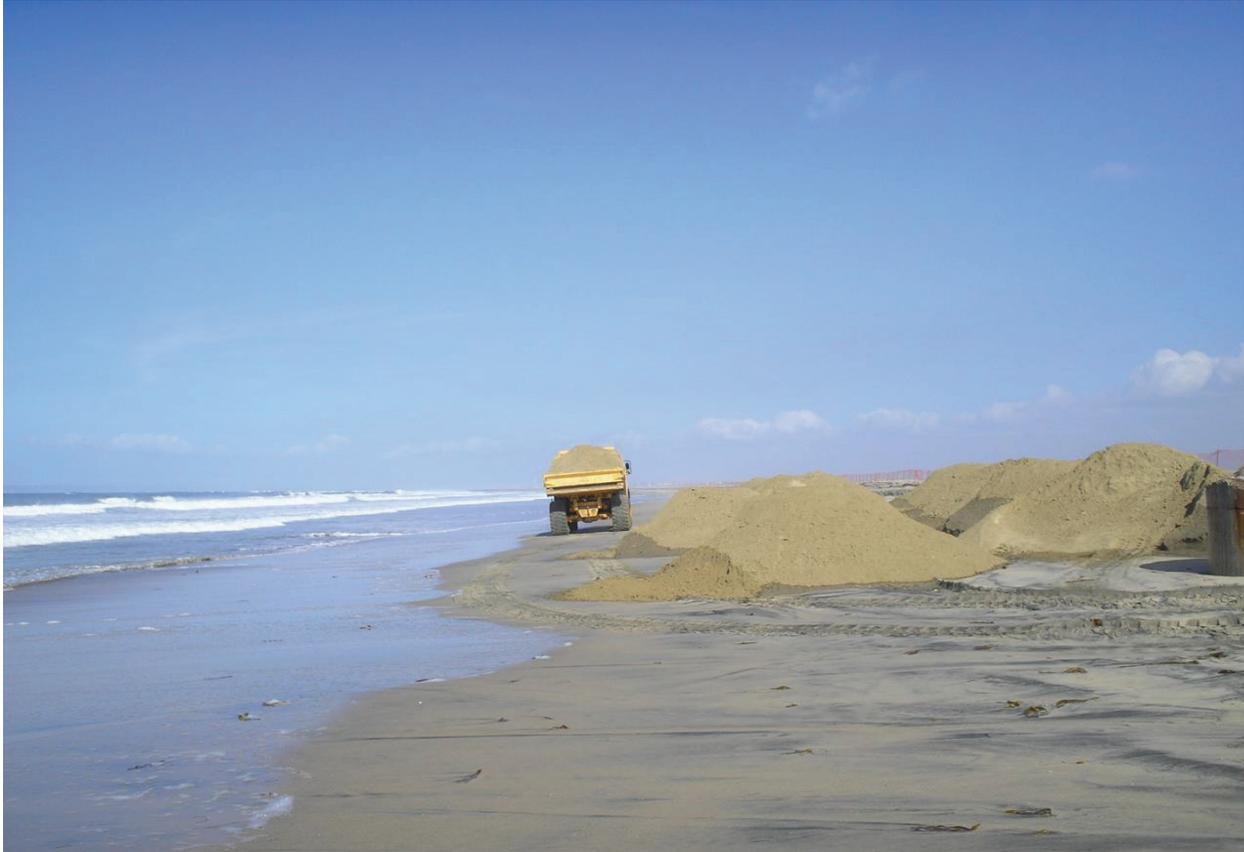
FIGURE 35. PLACEMENT OF SEDIMENT ON THE BEACH

during the project due to logistical and financial constraints. The initial phase of the altered project scope included approximately 10,000 yd³ of sediment that was deposited from November 3 to November 13, 2008 (Phase I). After completion of Phase I in 2008, a state funding freeze occurred and the project was halted. Funding from alternate sources in 2009 allowed the project to be restarted. The original scope was scaled back to include one additional phase. Phase II occurred from September 21 to October 2, 2009 in which approximately 35,000 yd³ of sediment was placed at the same placement

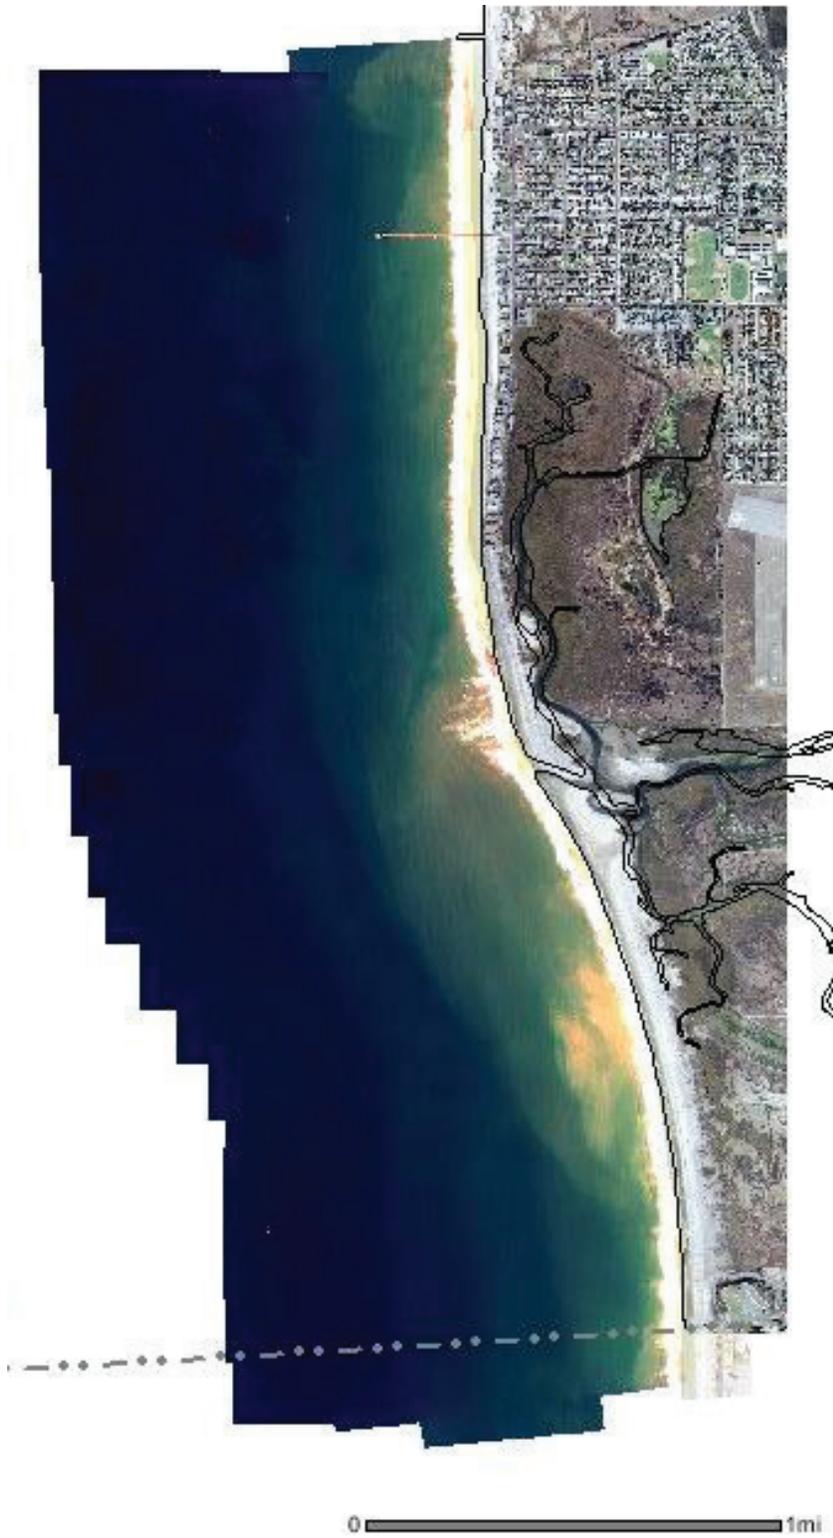
FIGURE 36. IMAGERY OF PLUME

Fate of Sediment. Swash sampling and ocean color remote sensing results suggest that the initial transport of fine sediment was strongly influenced by longshore currents of the surf-zone that were established by the approach angles of waves. Measurable fine sediment concentrations persisted in the surf-zone for several days after nourishment due to the slow winnowing of fine sediment that remained within the beach foreshore (Figure 36). Immediately offshore of the surf-zone, fine sediment was pulled offshore by rip currents and settled on the seafloor. Settlement on the seafloor was greatest immediately offshore of the nourishment site, although a mass balance of sediment suggested that the majority of fine sediment moved far away (more than two km) from the nourishment site to depths greater than

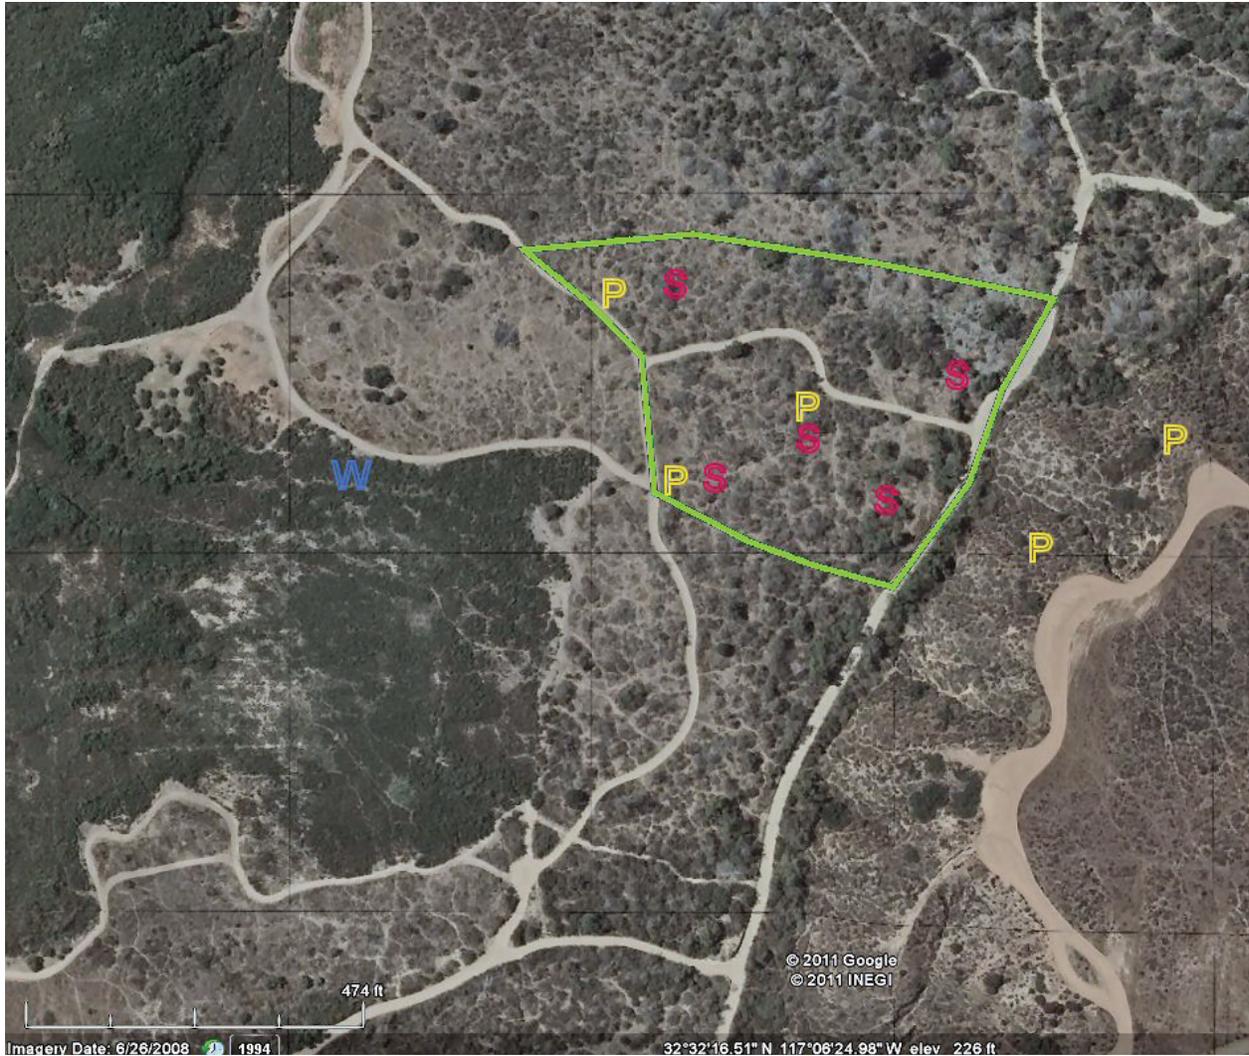
FIGURE 38.
 FIVE-ACRE RESTORATION PROJECT SITE (GREEN BOUNDARY)
 SHOWING THE LOCATIONS OF THE WATER SOURCE (W), PHOTO POINTS (P)
 AND VEGETATION SURVEY AREAS (S)

Quantitative Monitoring. Changes in the structure of the vegetation were documented by monitoring the vegetation along five 25-meter transects. Along each transect, the percent cover of each species was determined using the line-intercept method. The vegetation survey sites had been chosen
