40 YEARS OF RESTORATION AT TIJUANA ESTUARY, CALIFORNIA

LESSONS LEARNED

40 YEARS OF RESTORATION AT
TIJUANA ESTUARY, CALIFORNIA
LESSONS LEARNED

SEPTEMBER 2018

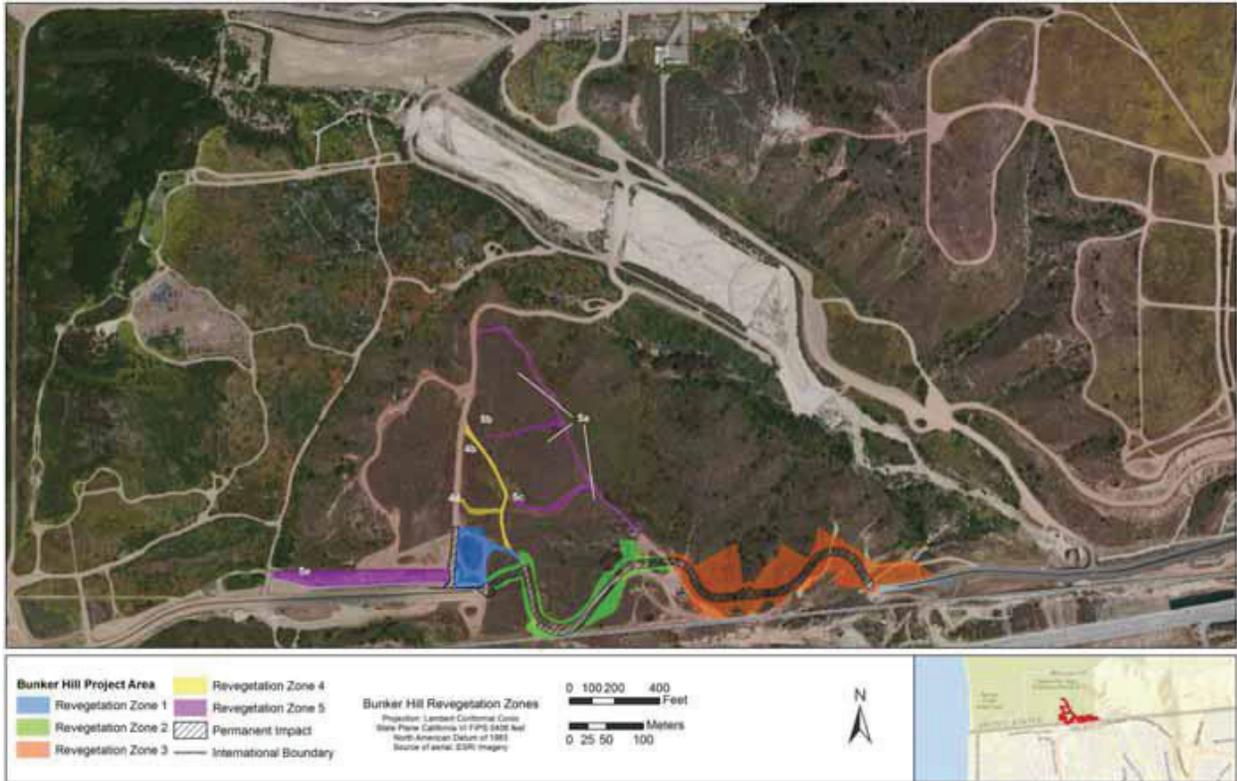
FIGURE 39. BUNKER HILL REVEGETATION ZONES

bags were employed where surface erosion was detected.

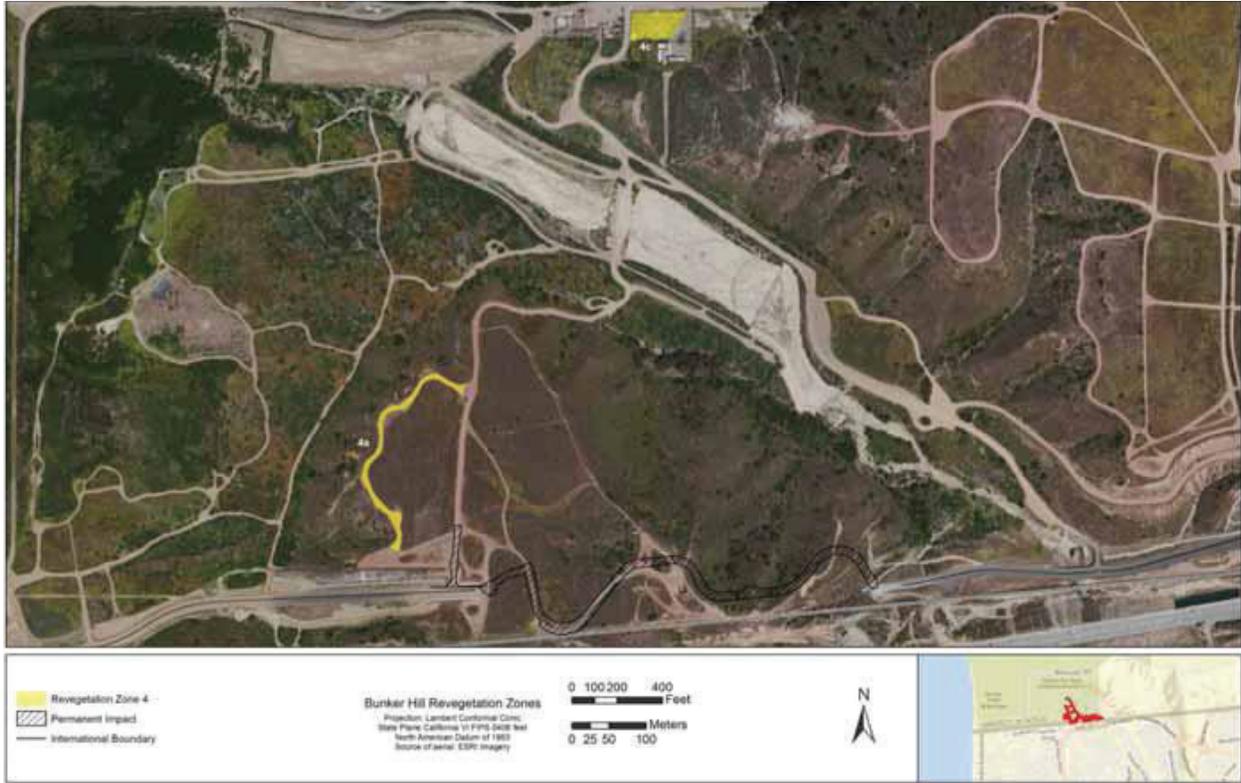
FIGURE 40. REVEGETATION ZONES 4A AND 4C

- Continue to monitor erosion annually;
- Continue to monitor mortality monthly during the growing season (November–April);
- Conduct revegetation activities originally planned for the Goat Canyon staging area;
- Determine if rehydroseeding is required in areas that did not germinate;
- Reseed hand-seeded areas.
